Manhole Inspection Summary

Manhole # S29MM_030MH

Insp Date: **7/17/07 10:00 AM**

Location Address: **2000 PARK AVE**

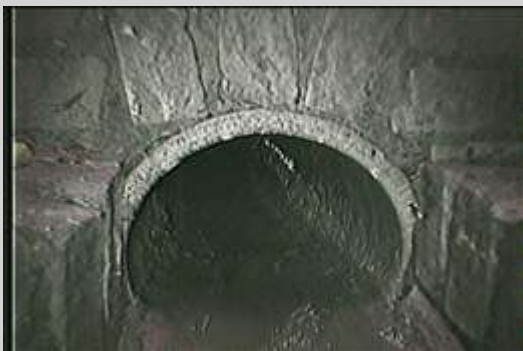
8 in. Circular Gravity Sewer Pipe In @ 3 O'Clock

Pipe Material: **Clay** ☐ Pipe Lined

Infiltration: **None** Pipe Seal Cond: **Unknown**
